AN/PRC-56 HELMET RADIO SET UPGRADING

Recommended modifications require minimal resources but promise considerable improvement in reliability, operability, and logistics support

JH Townsend

15 May 1977

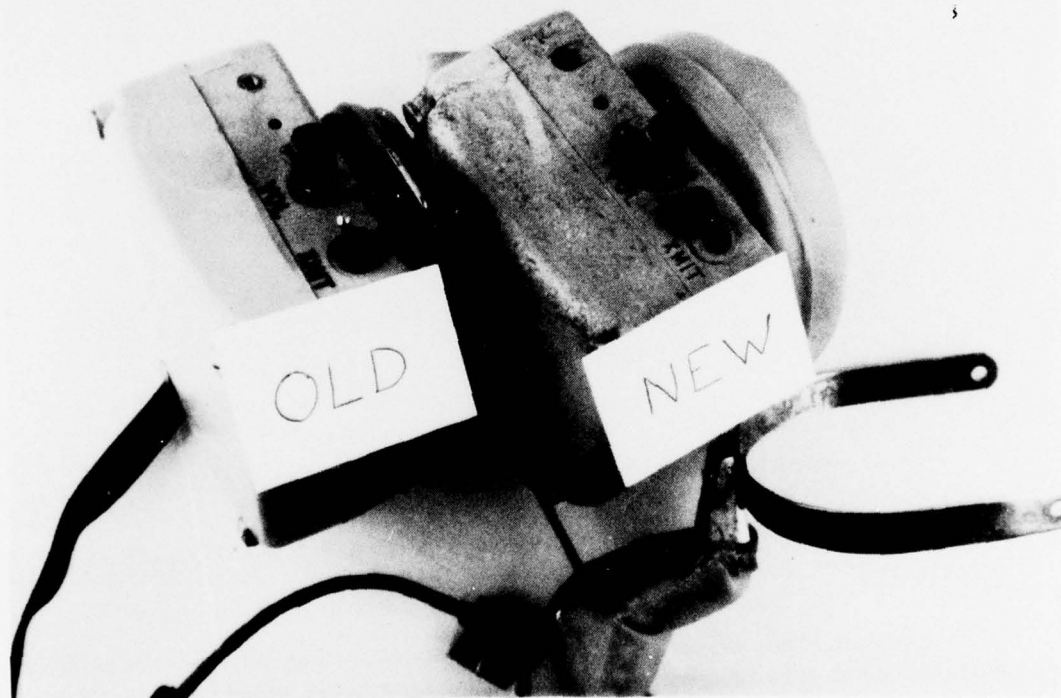
The miniature toggle switches used for the push-to-talk and on/off functions are both high-failure-rate items. Their respective replacement rates are each exceeded only by those of the above capacitor and the batteries. Neither switch is rugged, but both are subjected to severe strain. A common failure results from too much pressure applied to the toggle bathandle. The bathandle itself is easily broken, and the internal connections are also fragile. Since flight deck personnel wear gloves and the switches have a very soft action, users cannot feel or hear the switch action and tend to push hard to ensure the switch is "on"; damage to the switch often occurs.

Figure 2. The old and new push-to-talk switches. Notice that the new switch is relocated and that the switchguard has been removed. The hole resulting from the switch relocation has been filled with epoxy.

the normally open contacts. The best mechanical solution to the push-to-talk switch problem is to replace the existing toggle switch with a pushbutton switch. Miniature pushbutton switches with the rugged characteristics needed are readily available; two MIL-SPEC types were identified – M8805/64 and M8805/96. Both the M8805 switches are spst rather than spdt; however, this is a reconcilable difficulty. Also, although there is space for the switches, the mounting hole must be relocated slightly to fit them into the case. To resolve the spst/spdt difference, the receiver section was wired on, bypassing the push-to-talk switch, and worst-case tests (transmitter and receiver on the same frequency) were conducted to measure circuit stresses and to ensure no reliability problems would be introduced. This same fix was suggested independently as a solution to the problem of lack of sidetone (problem 11), since it allows the speaker to hear himself through the base station retransmission. Both the M8805 styles are satisfactory in fit and function. The M8805/96 has a more positive action and requires less force to operate, but the M8805/64 has a shorter plunger travel, which is compatible with a M5473/10-01 boot seal. Also, the M8805/64 is somewhat less expensive and easier to install; therefore, it is recommended as the replacement push-to-talk switch (fig 2).

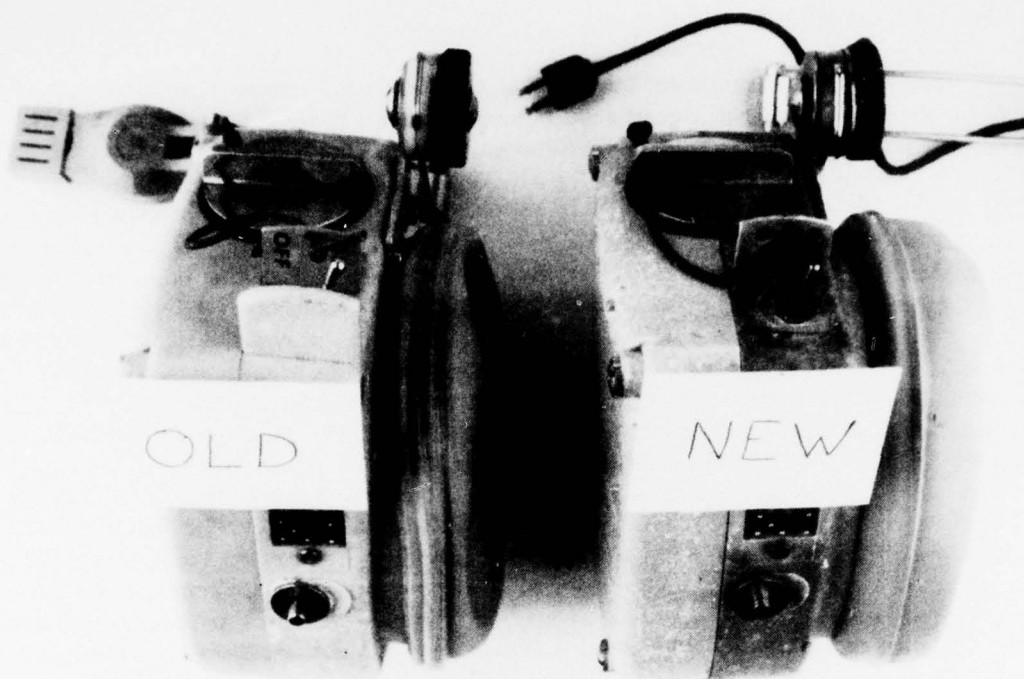
The on/off switch (fig 3) presents a different problem. The switch should provide a visual indication of its position in addition to being more rugged and dependable. Three types of switch were considered – toggle, slide, and rotary. No slide switches were found which

Figure 3. The old and new on/off switches. Notice also the alternate foam-filled ear cushion.

could be environmentally sealed and which could fit the spaces in the PRC-56 and the PRC-55. Several toggle switches and a rotary switch were identified which could fit, but all the candidates require a case modification. The candidates are as follows:

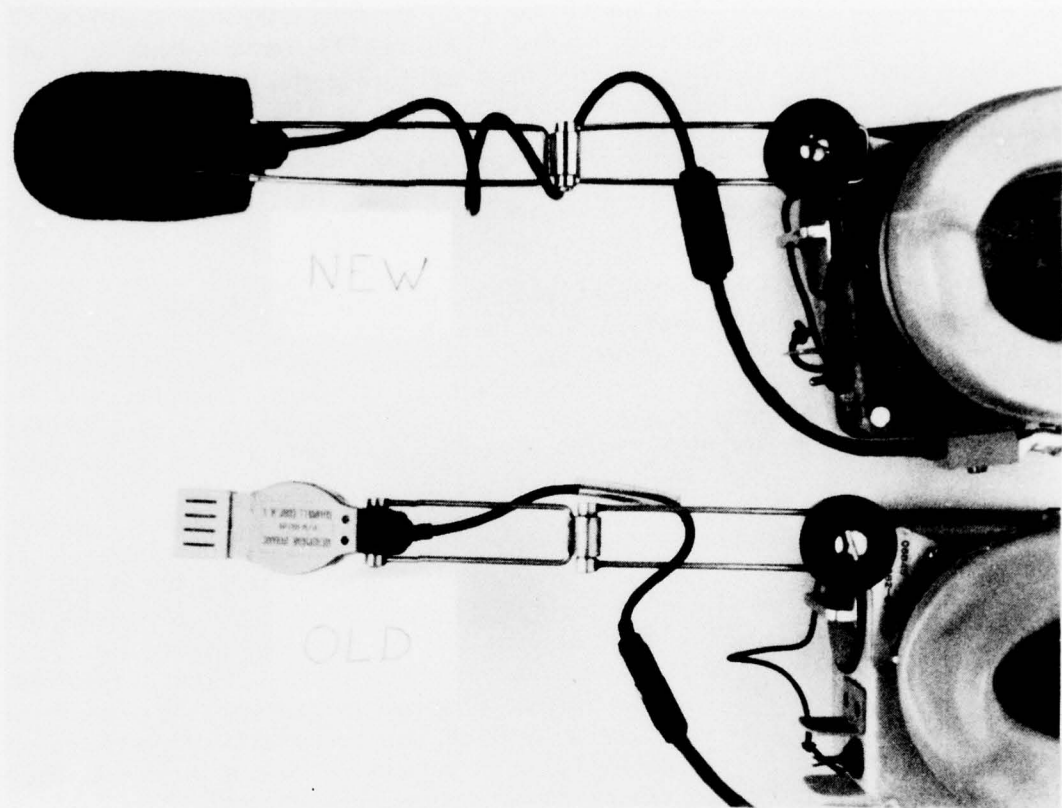
The M-87 microphone, microphone cord, and mike boom collectively suffer a very high failure rate. Failures in the microphone are both electrical and mechanical. The electrical failures appear to be caused by humidity admitted through either cracks in the case or leaks around the element seal. The cracks in the case are simply incomplete mechanical failures. A leaky element seal is most probably caused by the tearing or loosening of the seal by wind pressure. In fact, the M-87 is susceptible to saturation by wind; in the saturated condition, the output drops by at least 50 percent and the noise-canceling characteristic virtually disappears (problem 2). Another possible type of electrical failure derives from shorts or insulation breakdown, or, in conjunction with other failures, welding of the dynamic windings due to intense electromagnetic fields encountered on the flight deck (up to 200 V/m); however, there are no data confirming or refuting these failure modes. In any case, the primary electrical failure mode is humidity entering through a leaky element seal. The mechanical failures are mostly cracked cases resulting from rough abuse. The mike boom is a two-piece wire loop assembly. The most frequent failures occur at a weld on the hinge between the two pieces or at one of the wire loops. Virtually all the documented failures resulted from users' attempting to bend the mike boom to place the microphone closer to the mouth. The foreboom (the loop connecting to the microphone) is not long enough to fit all users comfortably (see fig 4). The failures to the microphone cord were breaks in the wires at the connectors (usually at the microphone end), primarily in the cloth-covered versions (as opposed to rubber or plastic coated). There are some false replacements of the microphone and cord due to input transformer failures, but these probably constitute about 12 percent of the total replacements. Research revealed a microphone assembly in the National Stock System which is made up of the M-87 with a windscreen, a mike boom with a longer foreboom, and a rubber coated cord; the stock number is 5965-00-181-0213. The windscreen will protect the M-87 from wind saturation, the element seal from wind tearing, and the case from much of the normal abuse. Additionally, the windscreen reduces annoying speech artifacts from "p" and "s" sounds and helps the user to properly position the microphone for maximum output and intelligibility.

Figure 4. The old and new microphones, boom assemblies, and connecting cords. The new boom assembly has a longer foreboom. The connecting cord is wrapped around the boom to avoid snagging and to provide strain relief.

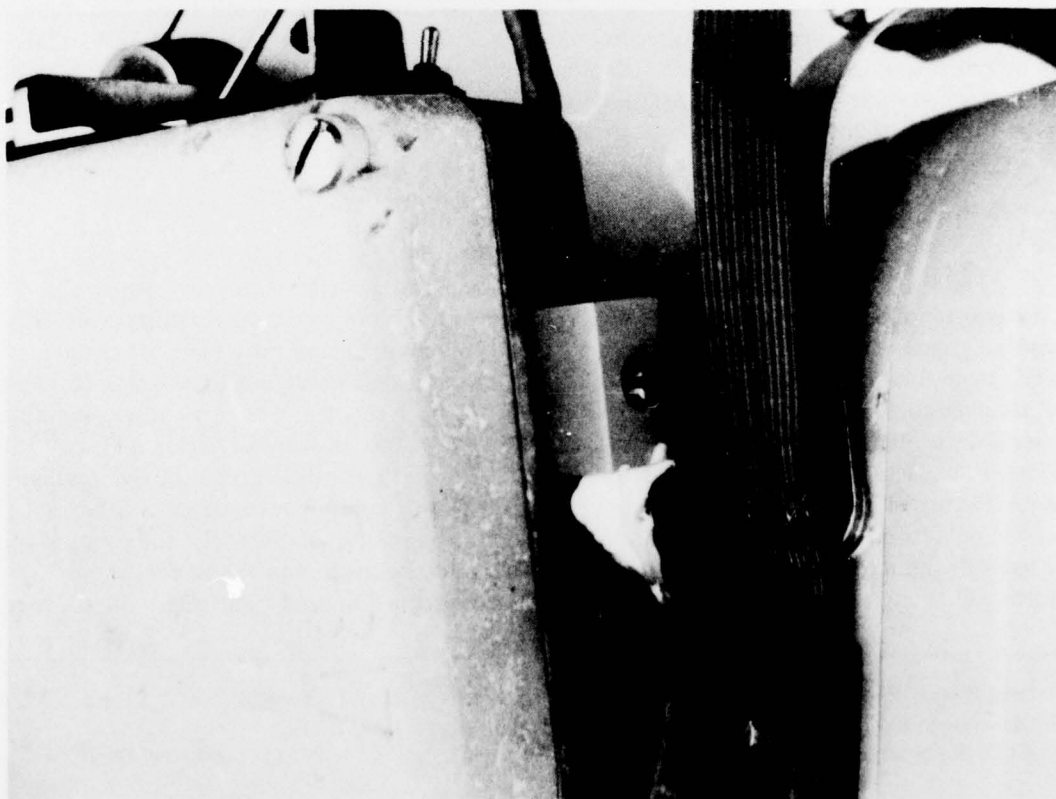
The cable assembly between the electronics pods has a moderately high failure rate. Many of the failures occur in the ribbon cable where it enters the connector blocks. At this point, the cable is flexed across its width rather than in line; this puts a severe fatiguing strain on the cable. In order to relieve the strain, it is recommended that adhesive sealant RTV-102 be applied in accordance with figure 5 or 6. Although other failures occur within the connector blocks, the design precludes doing anything to correct this problem.

Figure 6. RTV-102 applied to a connecting cable to provide strain relief. Notice how the cable is held away from the pivot on the earpod.

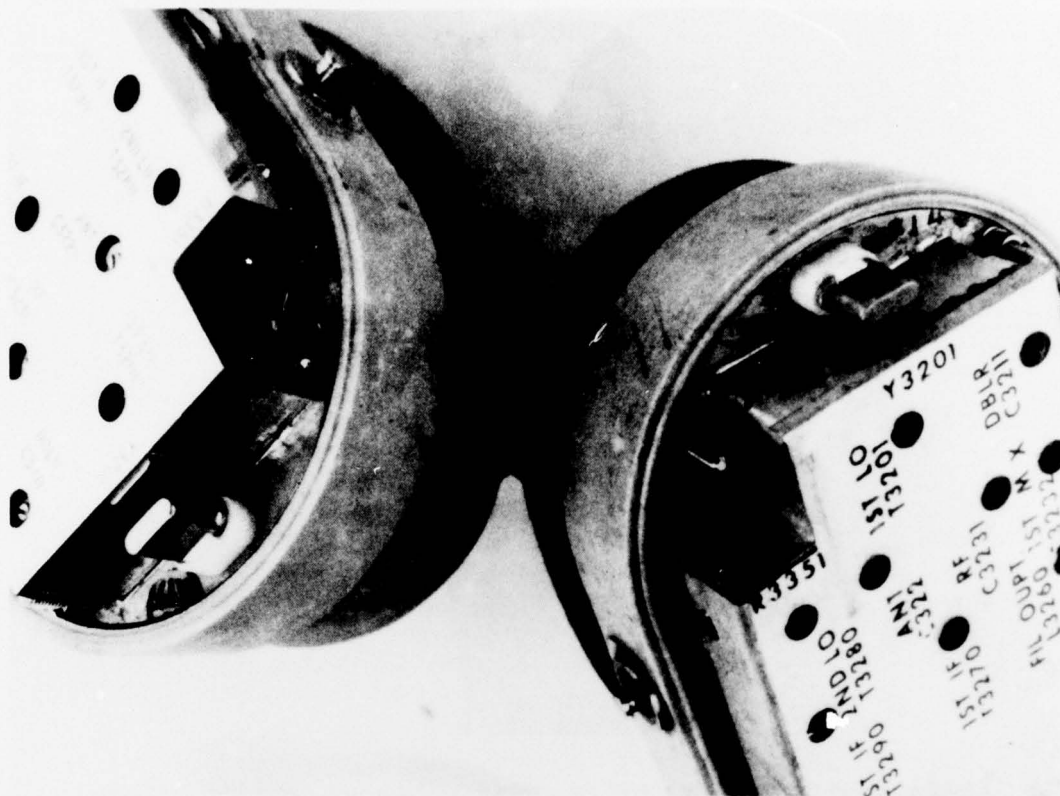
The squelch adjustment is too critical to be a practical adjustment. A very small change in the variable resistor used for squelch adjustment results in a large change in squelch threshold. In some units, a 100-ohm change (1 percent) is sufficient (because of worst-case tolerance combinations) to go from the unsquelched condition to a squelched condition which cannot be broken in certain operating positions by normal signal strengths. With the current variable resistor, a 100-ohm change is effected in only 3 degrees of arc. Furthermore, the current variable resistor is easily knocked out of adjustment by impact shocks. The radical misadjustment of squelch can appear to be a failure in the audio, squelch, or noise-AVC modules, which often leads to the false removal of these modules. A 10-turn established reliability MIL-type variable resistor is recommended to replace the current part. The new part, RJR26FW103M, will be much simpler to adjust, since 100-ohm changes will now be effected in 36 degrees. The part is stocked under NSN 5905-01-012-3770. Figure 7 shows the existing and recommended replacement squelch controls.

Figure 7. The new squelch adjustment installed (lower) compared to the old adjustment (above).

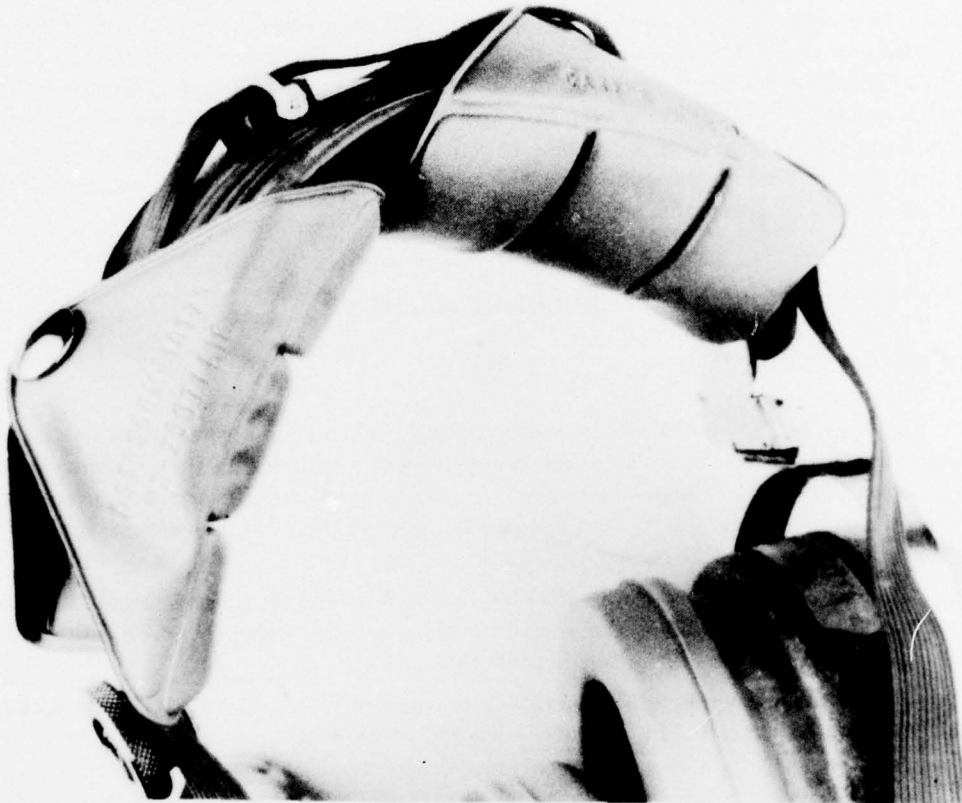
The two factors above plus a number of other minor helmet problems combine to create major problems of discomfort and irritating difficulties in the use of the helmet radio during operations. In some cases, an individual user is not aware of the irritation; however,

Figure 9. MX-2507/AIC pads installed to relieve pressure.

1. Most of the identified corrective actions can be accomplished easily as part of a field change. The proposed field change in appendix A is well within the capability of ship's forces. The field change includes new on/off and push-to-talk switches, a microphone with windscreen, a longer microphone boom, an improved squelch adjustment, improved-reliability parts, more-stable tuning, and sidetone.
2. Those users who are not subjected to the most intense noise levels (such as during catapult operations) should consider an interim replacement earseal (NSN 8475-00-940-9249) rather than the current glycerine-filled earphone cushion.
3. Those users who are bothered by a pressure point on the top of the head should install MX-2507/AIC headband pads over each end of the PRC-56 headband.
